SERVICE BULLETIN

BULLETIN NUMBER: SB-0018
REVISION: 02
DATE: JULY 2020 – Revised

PRODUCT DESCRIPTION: Paging Modulator Card

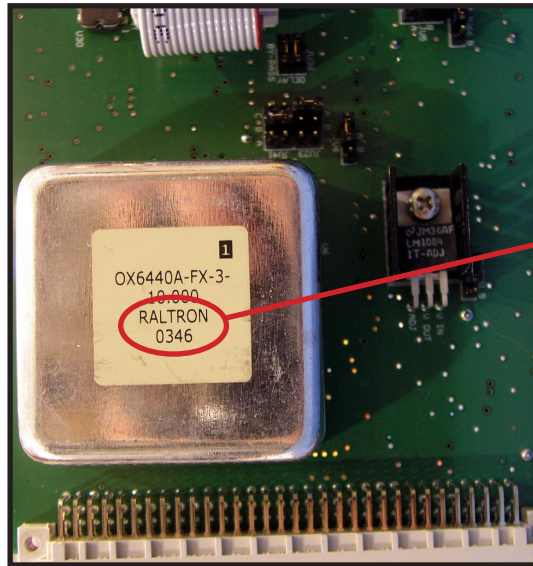
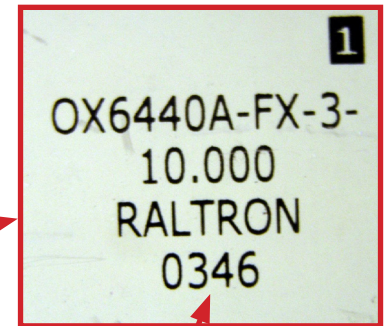
CAUSE : Flux and solvent contamination inside the Raltron 10Mhz OXCO may cause a short which would lead the 9.5V regulator to fail, which may lead to excessive heating and burning of the circuit board.

Problem applies to all RALTRON OXCOs with date codes less than 0610

1. Contact Codan to arrange for a new replacement OXCO and rework instructions.
2. Contact Codan for return authorization for warranty repair or replacement.
