SERVICE BULLETIN

BULLETIN NUMBER: SB-0041
REVISION: 1-0-0
DATE: AUG-2009

PRODUCT DESCRIPTION: CI-BC-4E Clear / Secure switching while in Local mode – CI-BC-4E base control module

PRODUCTS AFFECTED: CI-BC-4E-00 with switch (PCB 50139-02)

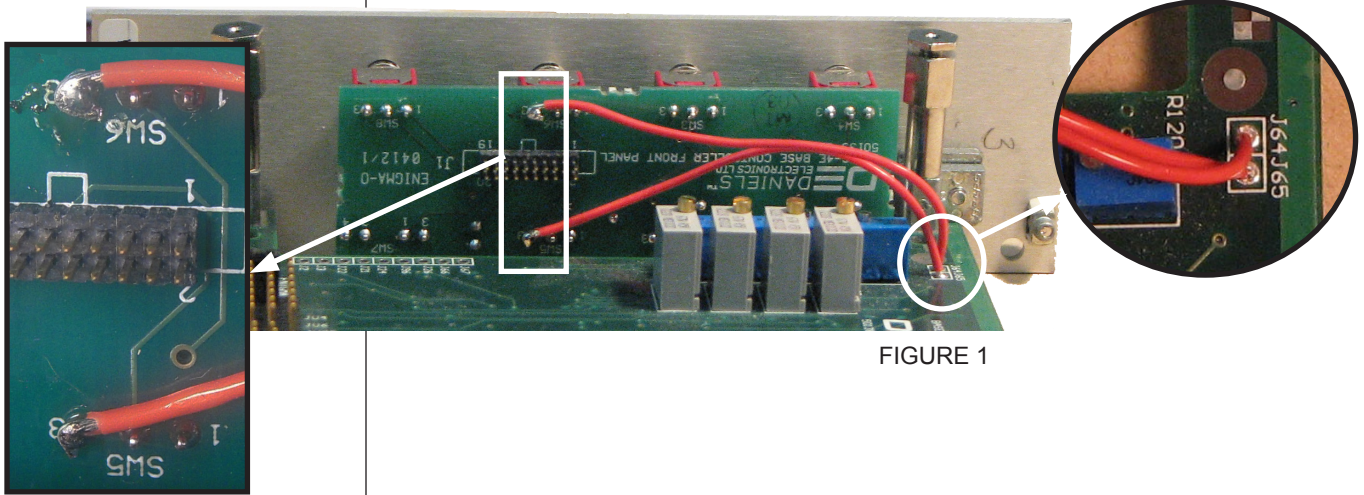
FIGURE 1

SYMPTOMS: MT-4E Transmitters with an encryption module installed will not switch to secure mode when Local control is enabled.

CAUSE: The clear / secure line is missing the required pull-up voltage.

PROCEDURE: Connect one wire jumper from front panel SW5 Pin 3 to J64 on main PCB top and another wire jumper from front panel SW6 Pin 3 to J65 on main PCB top (see Figure 1). Also replace R151 and R152 (see Figure 2).
